United States Department of the Interior
National Park ServiceNational Register of Historic Places
Registration Form

historic name Lexon
other names/site number Burris-Brockmeyer Farm QA-107

Lexon is a third quarter eighteenth century two story brick house with a gable roof, center passage single pile plan, and Federal and Greek Revival interior decorative detailing resulting from changes in the first half of the nineteenth century. The house stands on the south side of Corsica Road with a string of twentieth century domestic and agricultural outbuildings lined perpendicular to the south of the house. Reoriented in the first half of the nineteenth century, the present facade or north elevation, asymmetrical in arrangement, was the original back elevation. The structure has simple brick details; a square section water table, jack arches, and no belt course. The interior of the first floor and the east room on the second floor have Federal and Greek Revival mantels, stairs, and decorative detailing. The west side of the second floor has one paneled chimney wall dating from the first period of construction. This section is also divided into two spaces by a vertical board wall with t

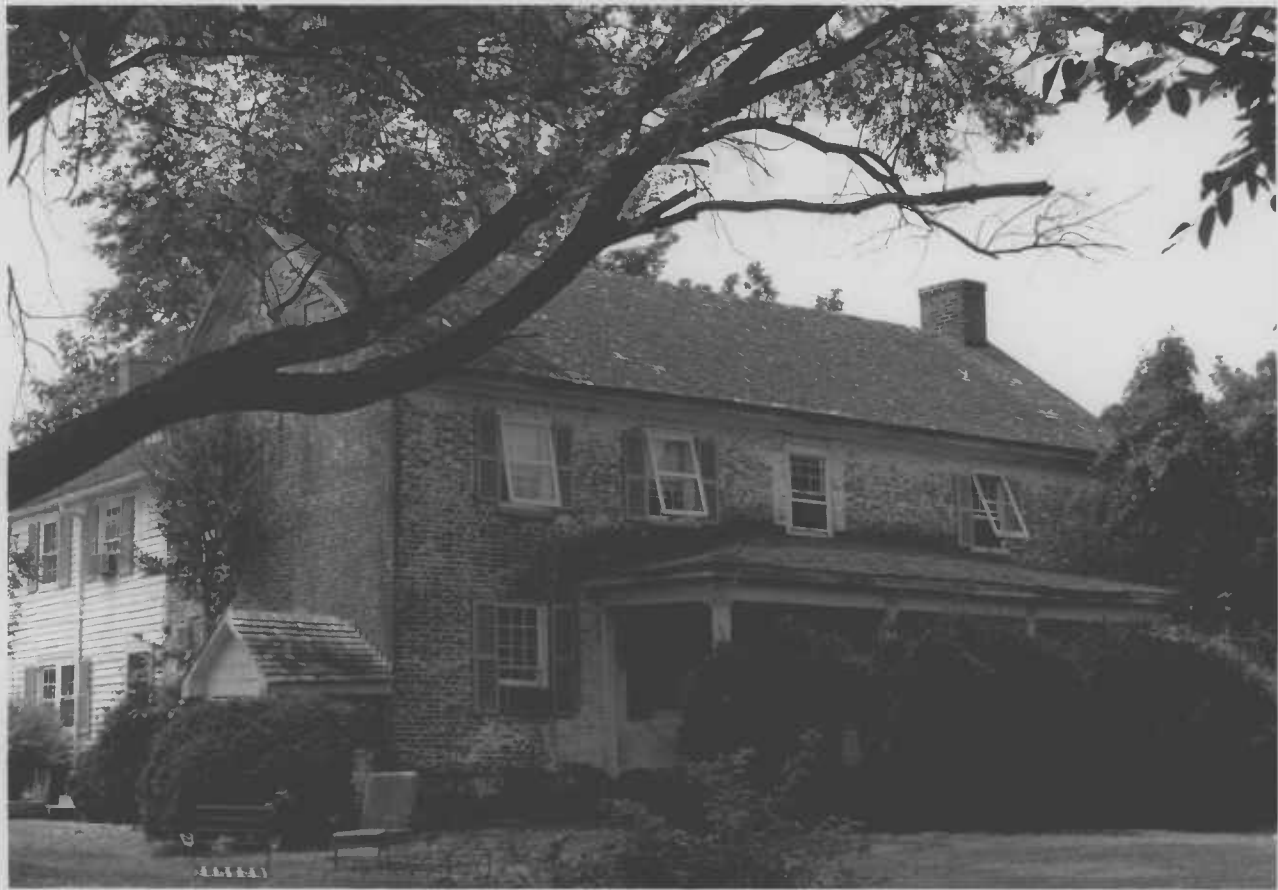
1/8

N.E. elevations

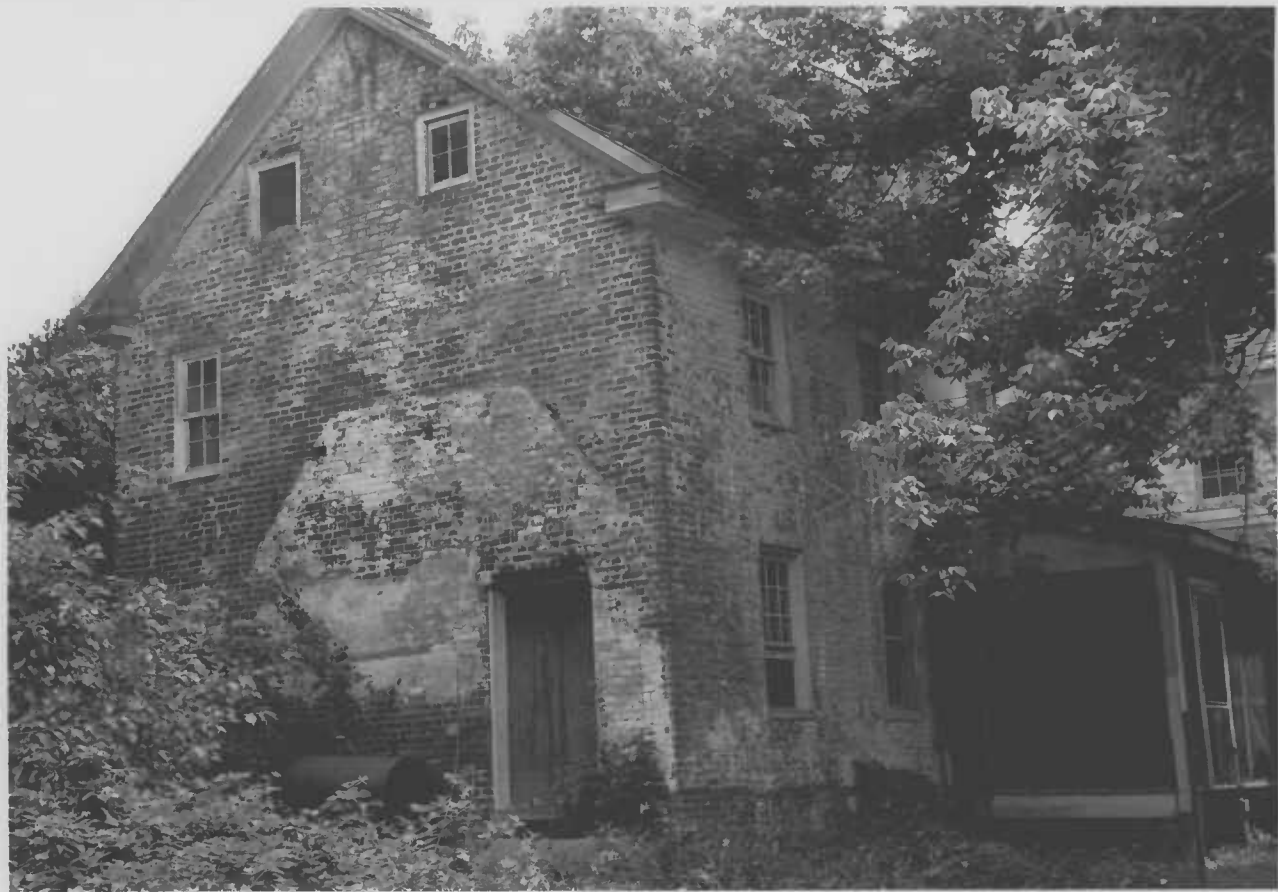
3/8

S.W. elevations

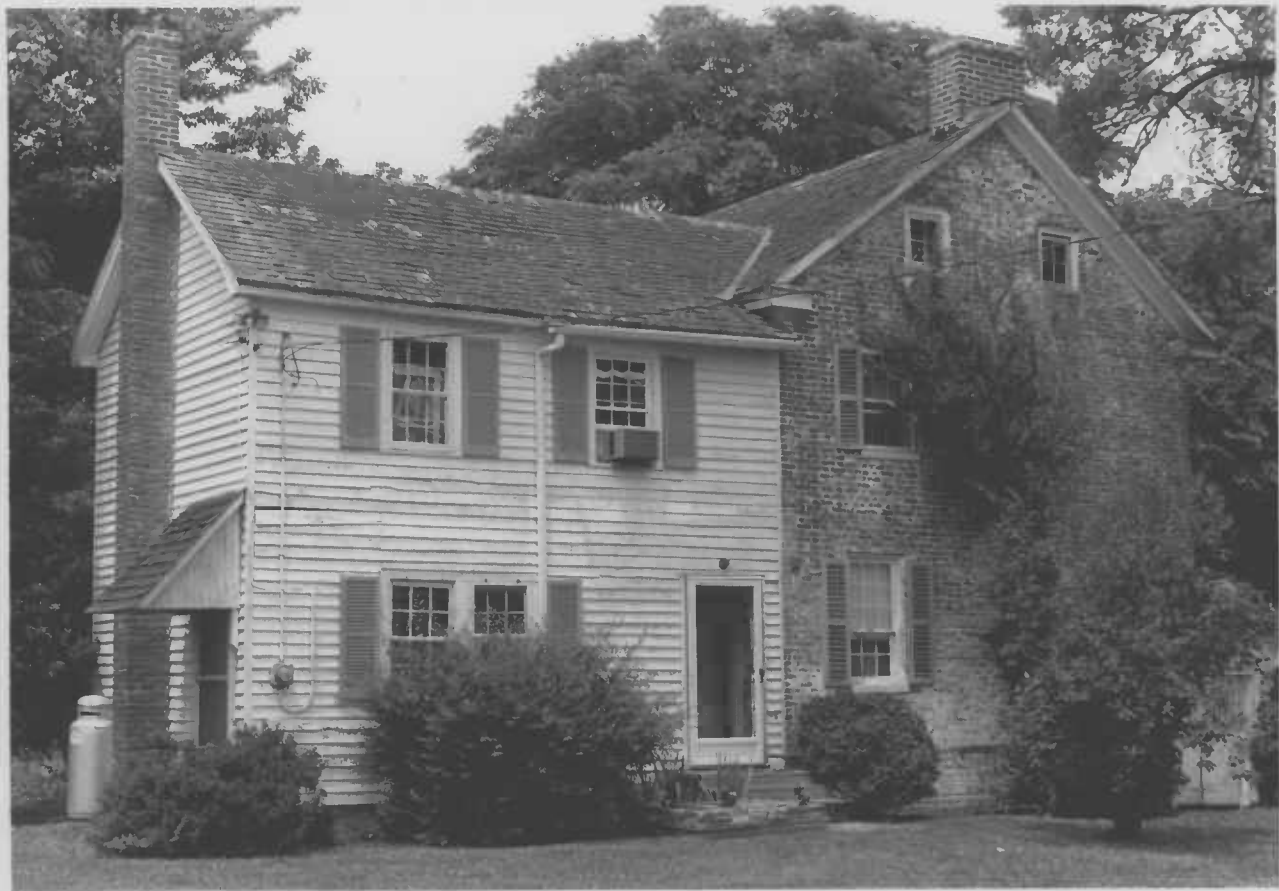
S.E. elevation

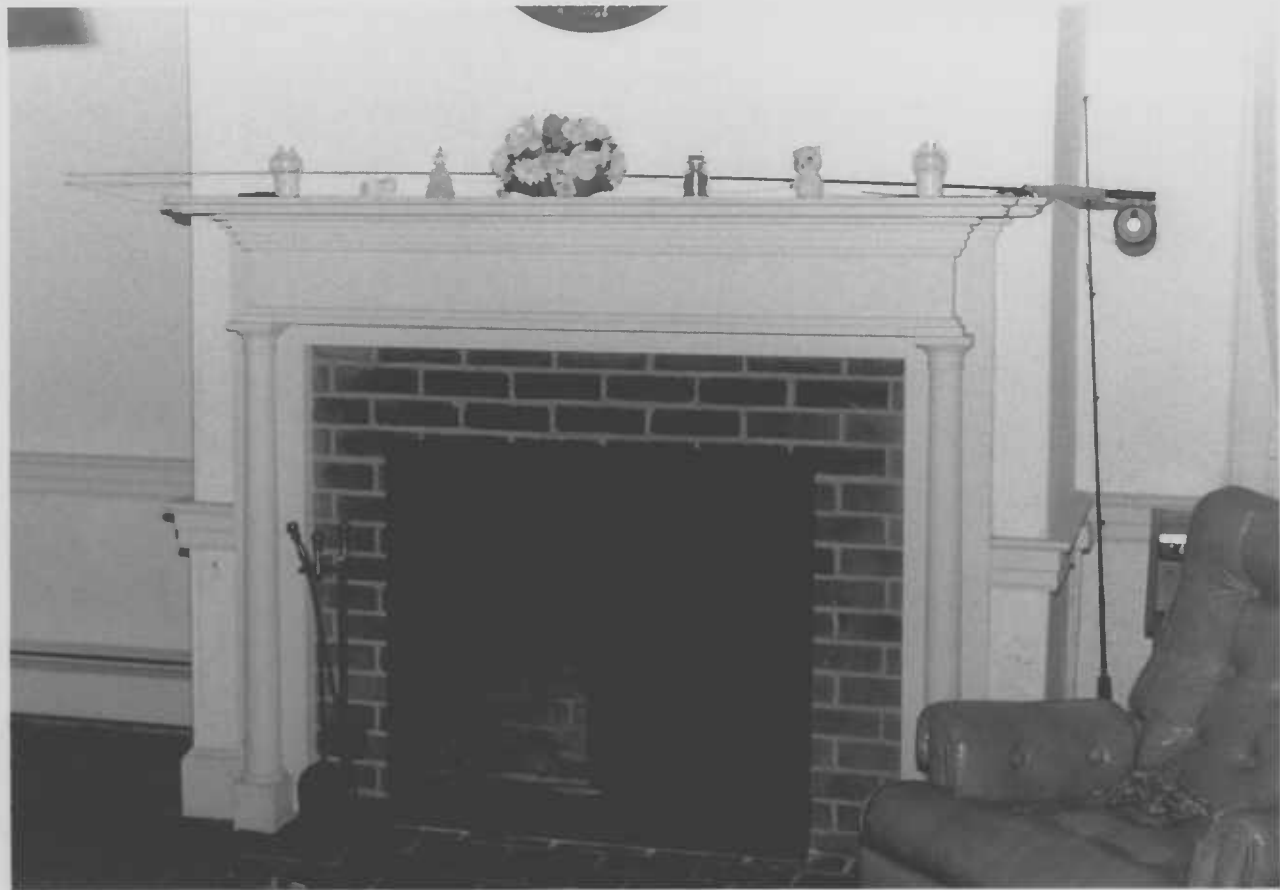
4/8

The east parlor is slightly larger than the west parlor. The fireplace is centered on the gable wall. A large Federal mantel survives. Plain board surround with plain Doric columns support a plain frieze with band of molding below, and a very heavily molded shelf. There are no blocks; the shelf breaks back about 1 1/2 inches from each end. The mantel is actually more Greek; the columns and moldings are dominated by three different Greek profiles. Molded baseboard and chairrail are the same as in the hall. The windows have splayed jambs but are not paneled. The sash is set in beaded and channeled frames. The architrave is in Federal cove/astragal, against beaded fascia.

First Floor east parlor mantel

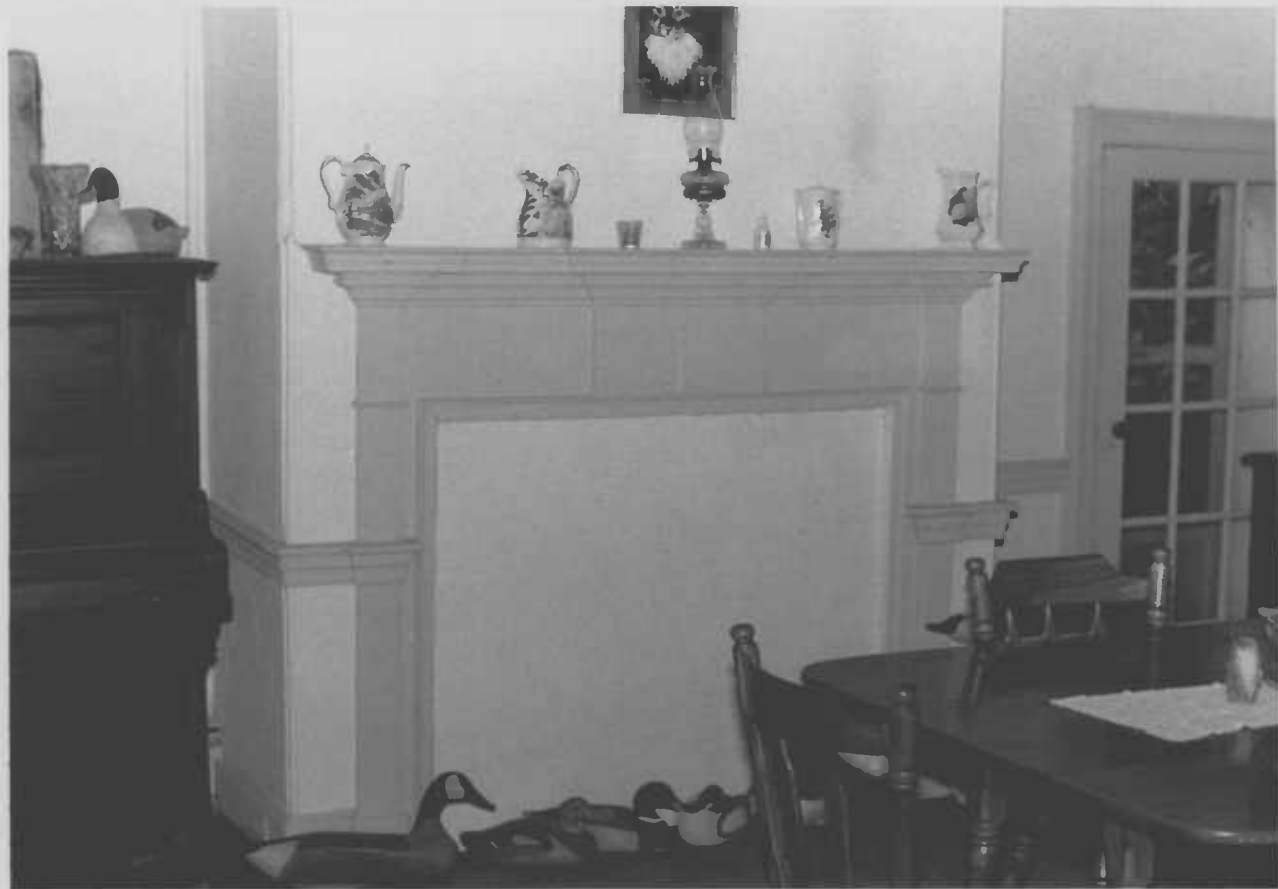
5/8

The west parlor also has a centered fireplace with Federal mantel, board surround with plain pilasters, side and center blocks, and plain frieze. The molding sets off the opening and the shelf is heavily molded which breaks forward above all three blocks. Chairrail and baseboard are the same as the rest of the first floor, but the chairrail on the north wall is solid field, still with the same shelf and astragal. Window architraves on the south wall are cove/astragal. The window on the north wall has ogee/astragal that matches the door architrave to the right of the fireplace. The blocked door is to the left of the fireplace but the chairrail crosses the opening, so the door must have been blocked in the second quarter of the 19th century.

First floor west parlor mantel

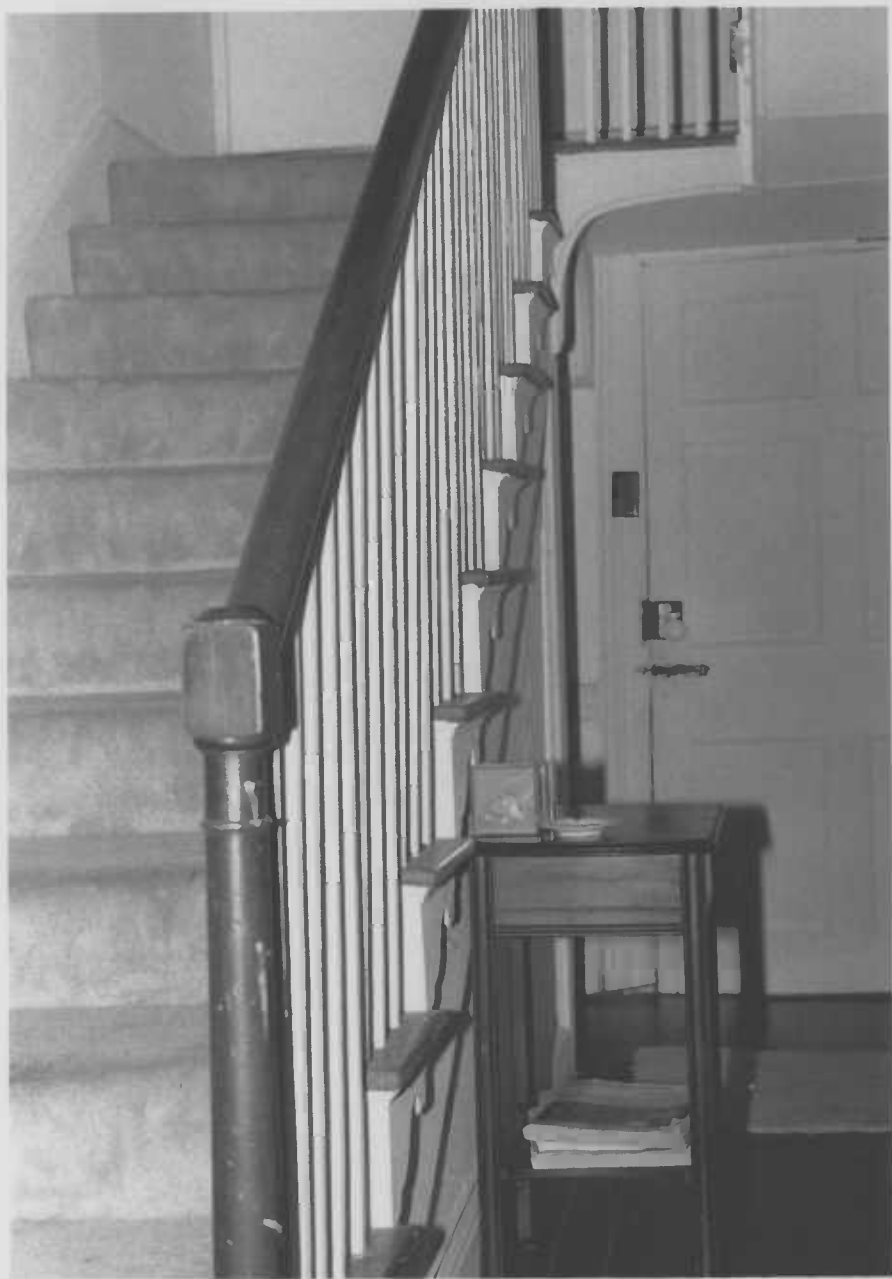
6/8

The interior has a first floor, center hall plan with single nicely proportioned parlors on either side. The stair hall is slightly wider than usual and has an open string stair rising against the west wall. The newels are delicately turned with a simple block cap. The rail is molded and the balusters are square with a very fine bead on each corner. There are scrolled solid brackets on beaded carriage and plaster panel below. The baseboard is molded. The very fine, six-paneled door on the north end of the hall has boldly raised panels (late 18th century or earlier) and ogee panel molds.

First Floor staircase

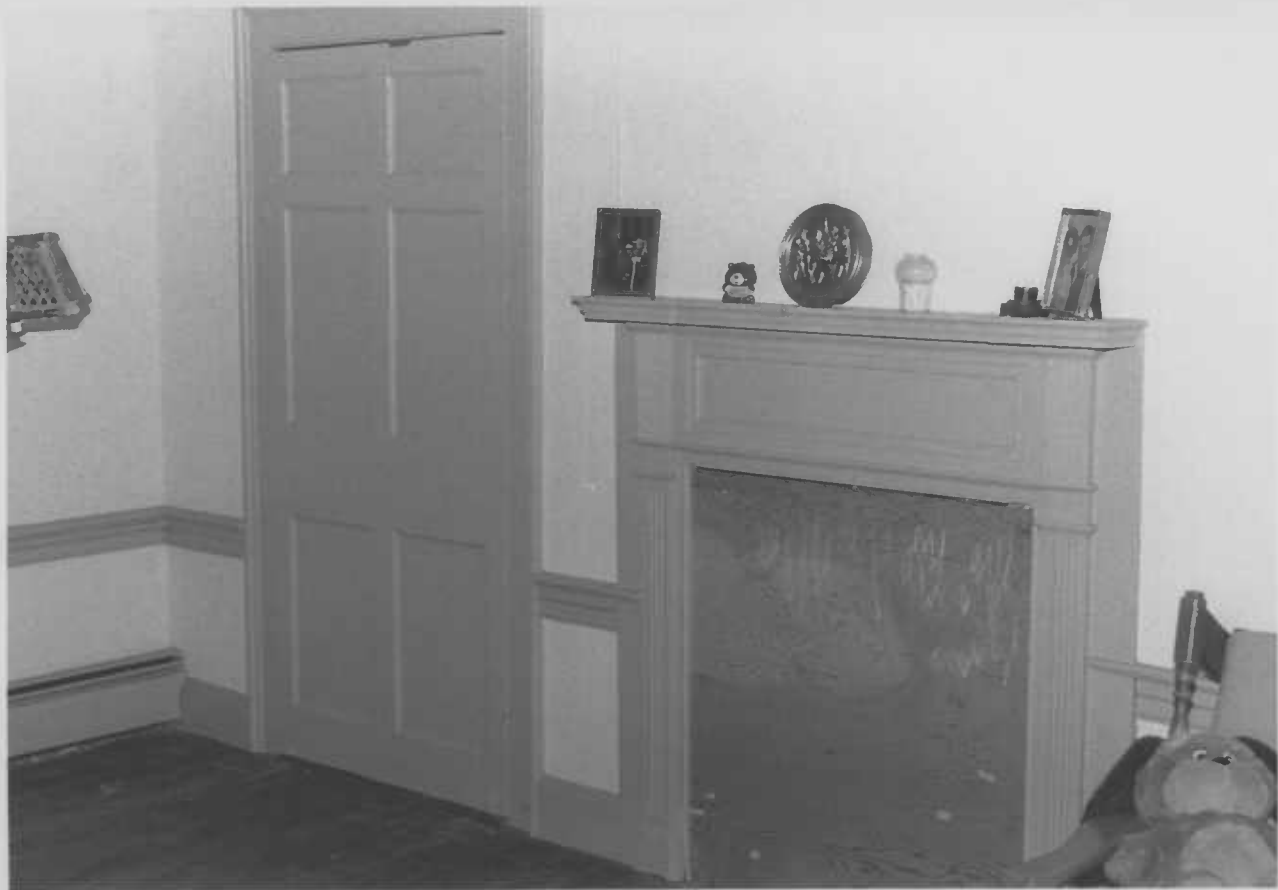
7/8

2nd Floor, east chamber mantel

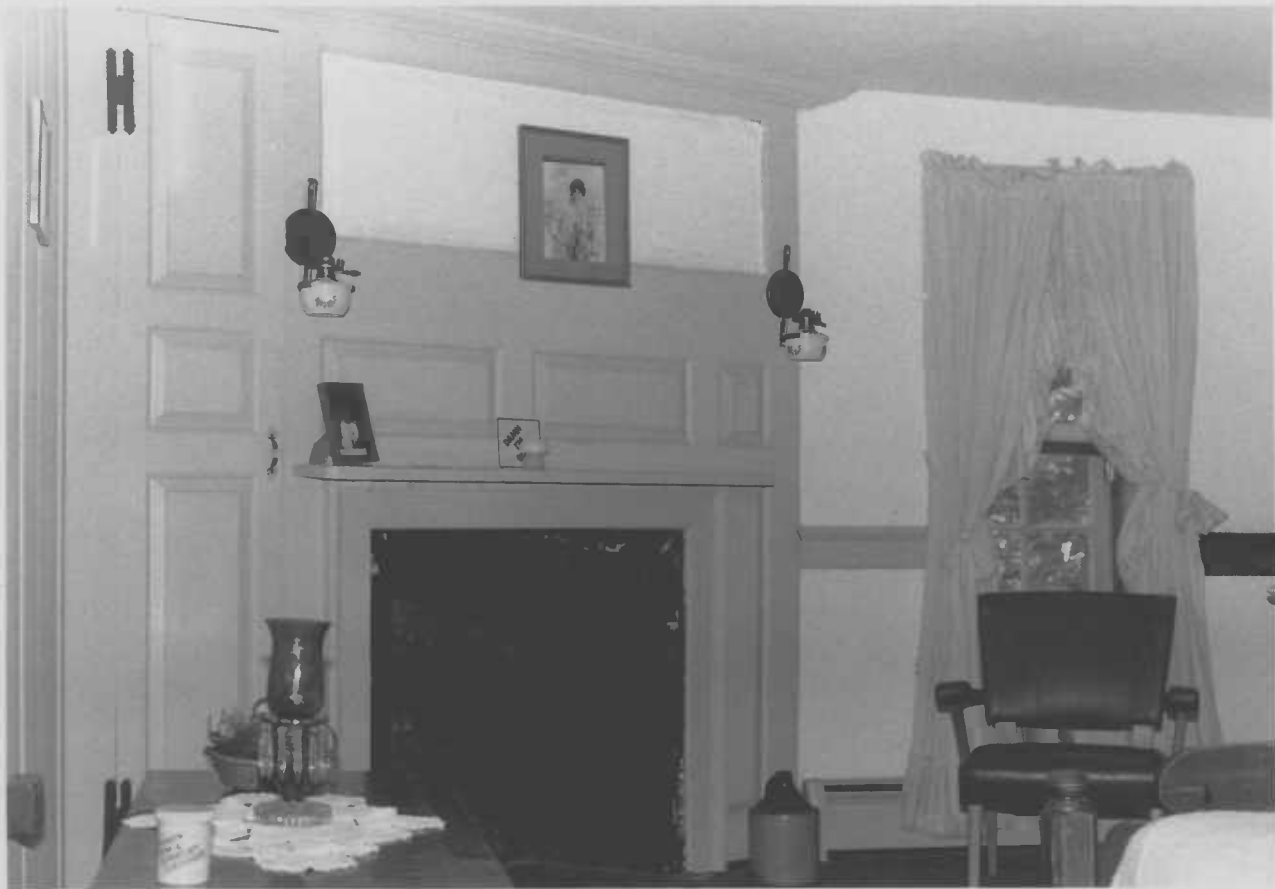
8/8

2nd Floor, N.W. chamber mantle
(and paneled wall).

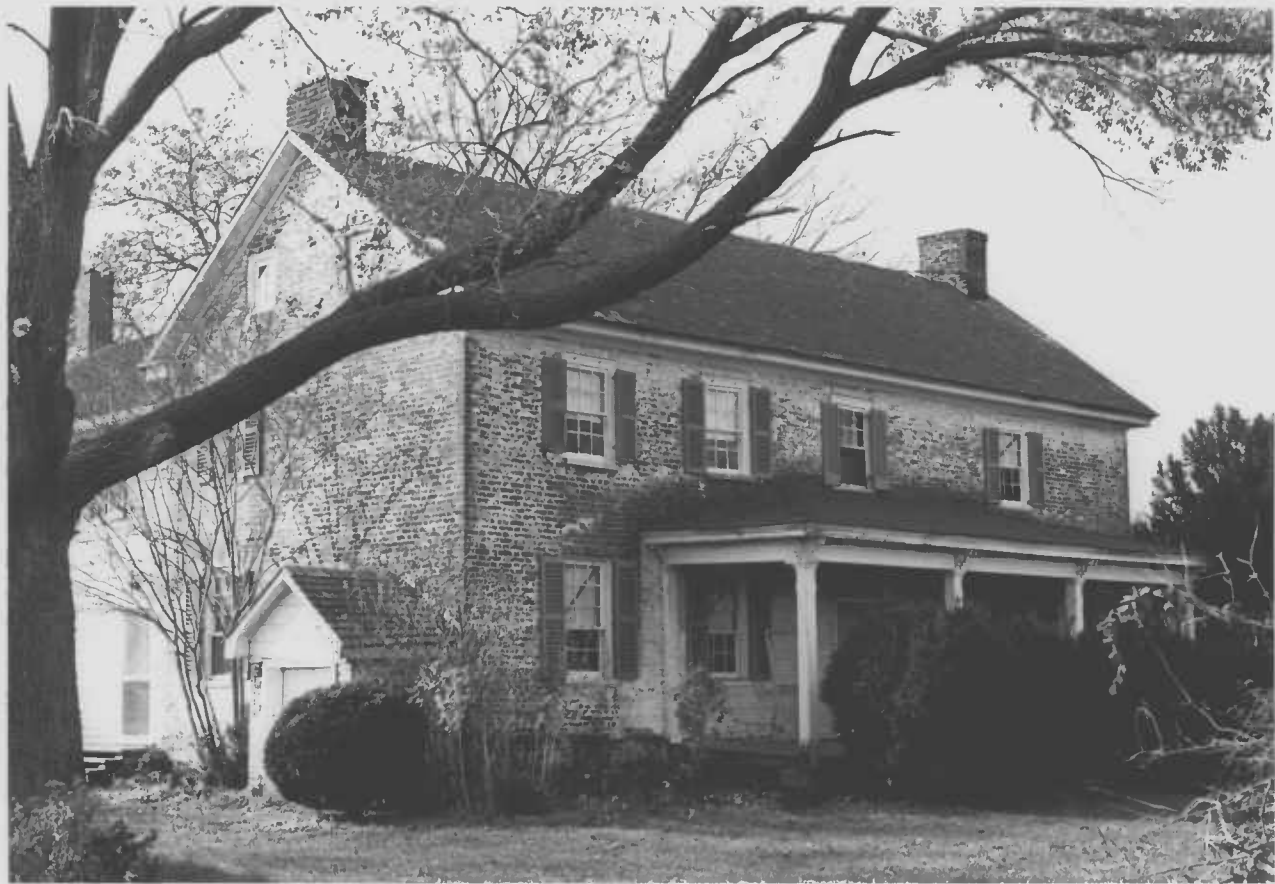
The north facade, which is now the front facade, faces the road. It is of Flemish bond above a plain water table. The door which is in the center bay has no transom. Two 9/6 windows are to the left of the door and one is to the right so the fenestration is not balanced. All have rowlock lintels. The same pattern exists on the second story with 6/6 lights and rowlock lintels. The center window is not downset. The cornice and roof are the same. A one-story late nineteenth century porch with chamfered posts and small double brackets below soffit, above each post, stops 7-8 degrees from each gable end. Of particular interest are surviving early louvered shutters with very wide beveled louvers set in pegged wooden frames. These are the first recorded example in Queen Anne's County and may be original, but certainly are early 19th century. Two cellar windows flank the door.

Lexon
Centreville vicinity
Orlando Ridout V 1980
Front facade from Northeast

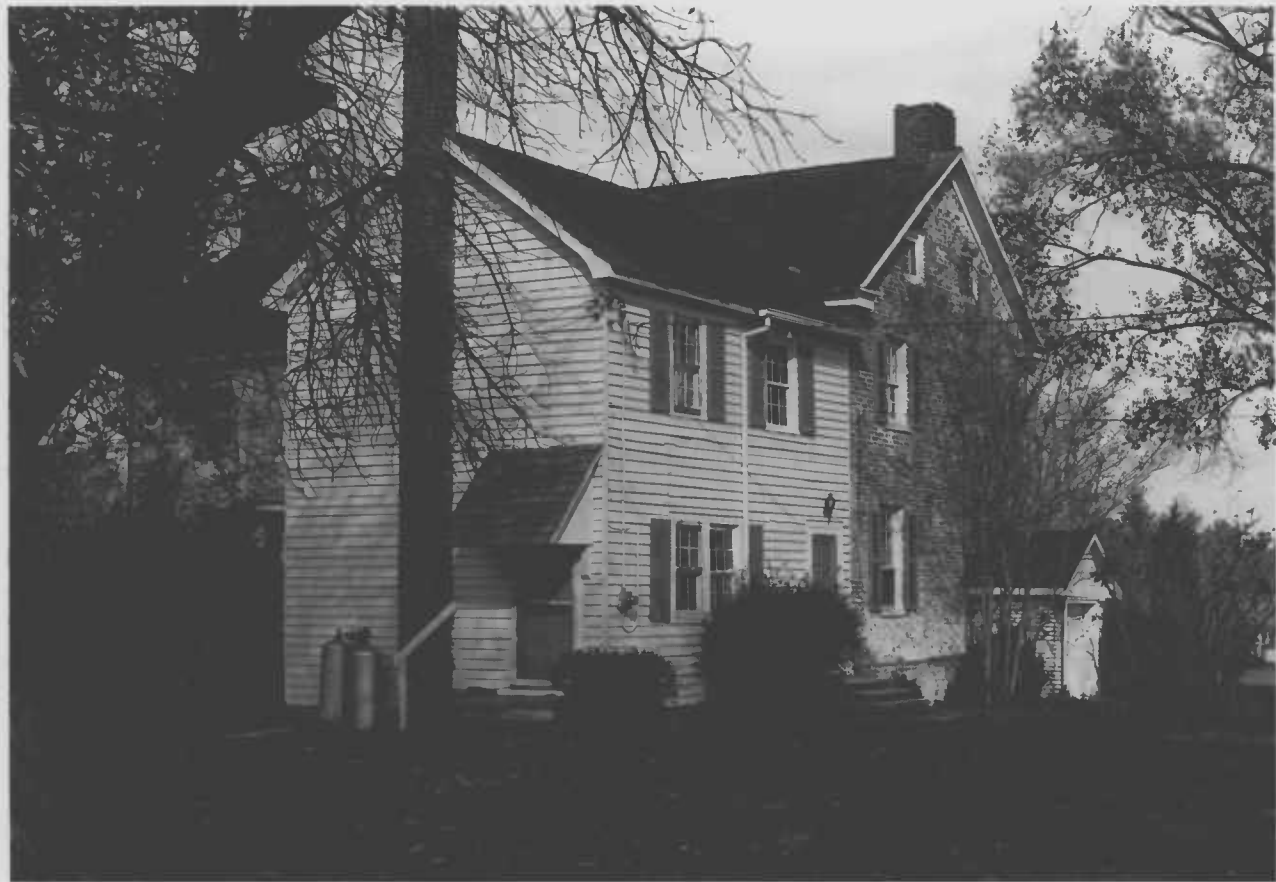
View from Southeast

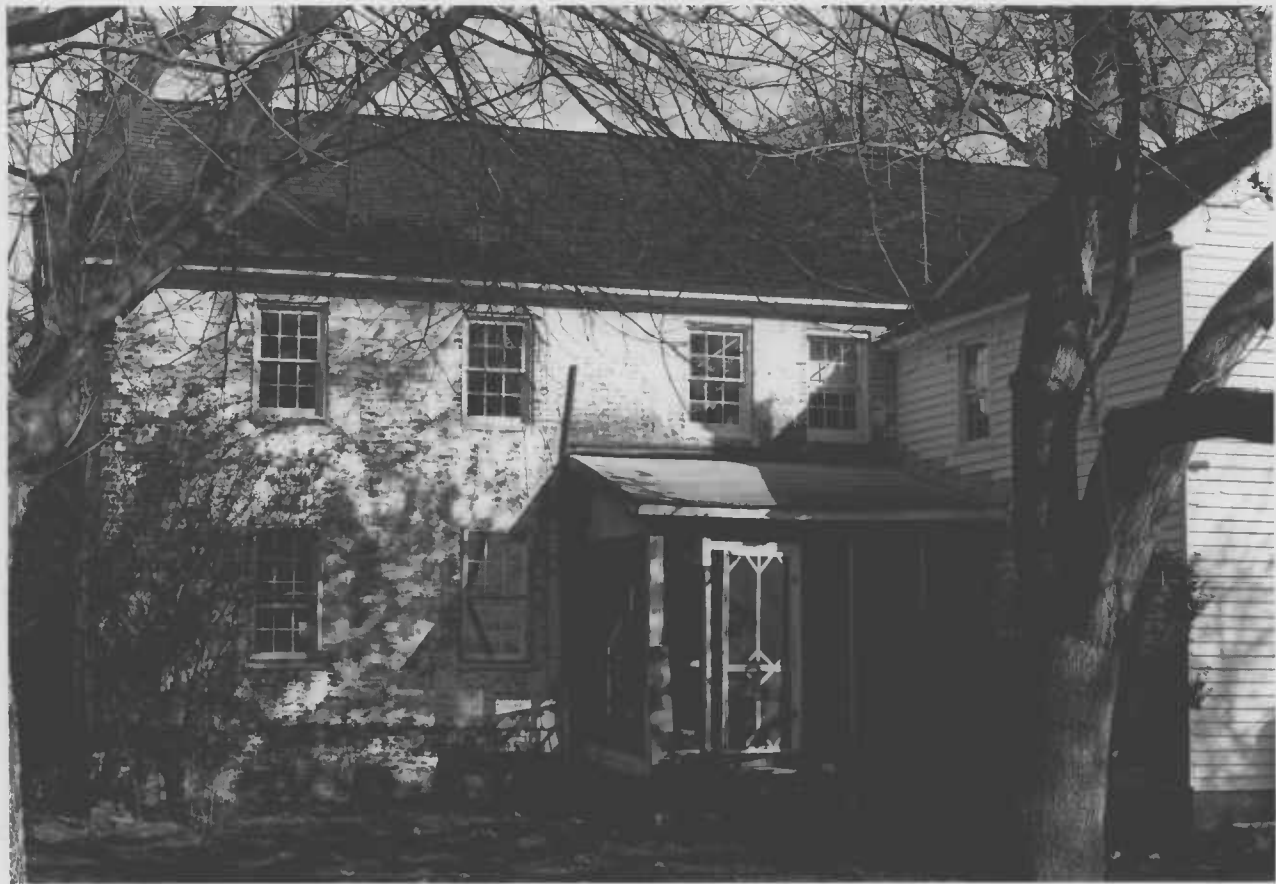
The foundation is laid in Flemish bond and the pattern continues above a plain water table. Openings have king closers. There is a box cornice with crown mold and bed mold which originally stopped at corners but in later 19th century was extended to return at gables and carry up the eaves. Seams are visible where later work was added. Beveled pieces substitute for molding. The roof is shingle. A small screen porch covers the center bay of this facade on the first floor.

Rear facade from South

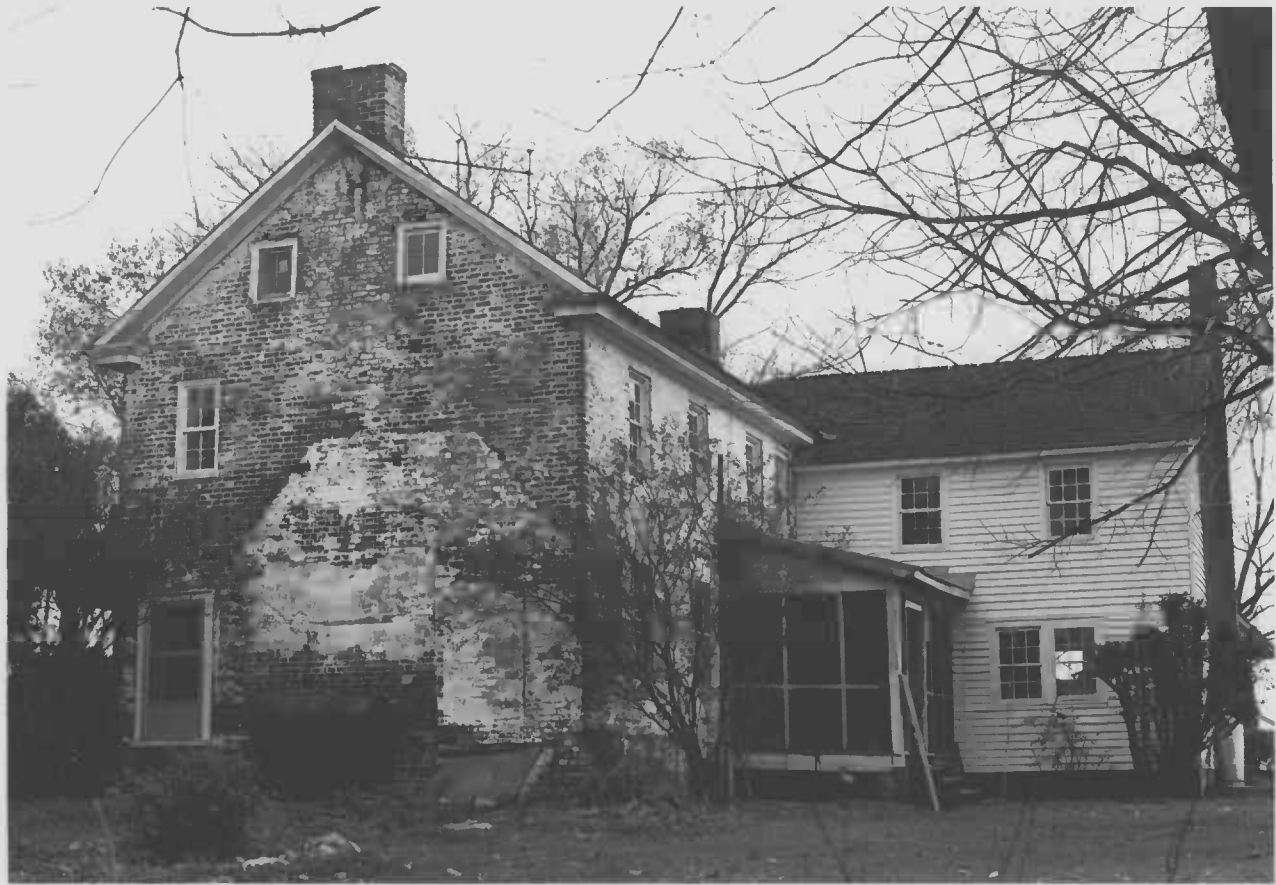
The west gable end is of Flemish bond above a plain water table. Bonding occasionally breaks pattern, particularly in ground and upper gable, largely due to openings. There are numerous glazed headers in the upper portion but no pattern. The door is in the extreme left bay on the first floor; there is a blocked door opening in the extreme right. The right door is original and the left was probably cut in later. There is a rowlock lintel above the right and none above the left. The door jambs on the left are concealed by trim. Cellar entrance is cut in below the right door. The outline of a demolished addition covers most of the gable wall. The north wall of the wing was set into the main wall; covering is still evident but no similar evidence is visible on the south wall. An outline in whitewash shows silhouette of building and cellar locations. There is a 4/4 window on the second floor above the left door. A pair of 4 light attic windows flank the chimney in the upper gable. Rakeboards have been replaced in second half of 19th century wing with box cornice. The flush brick chimney is in the center of the gable.

Main house from Southwest

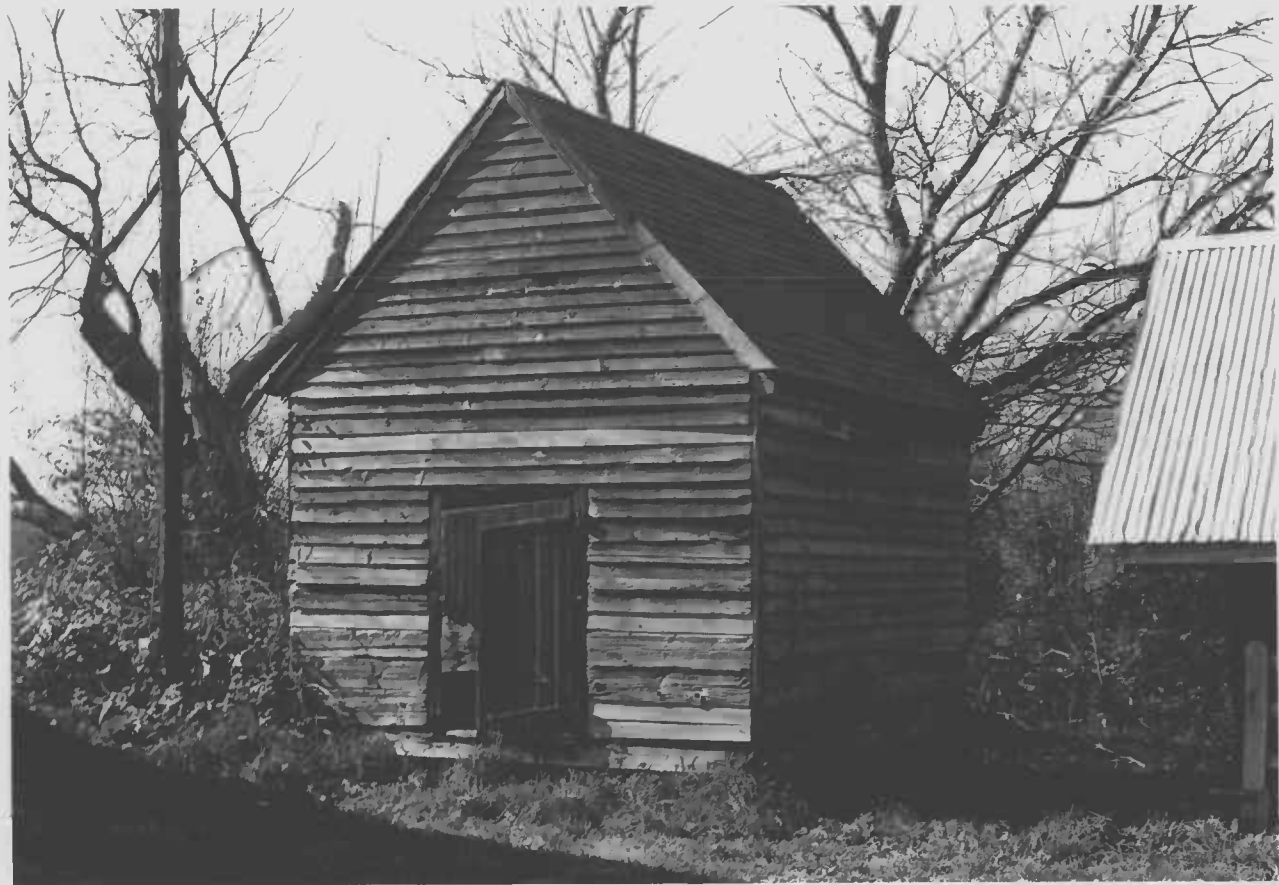
The meat house is of heavy timber frame construction, measures 12 feet deep and 14 feet long, with steeply pitched gable roof. The building rests on L-plan brick piers and is covered with plain horizontal siding secured with mature machine nails. The only opening is a door centered on the east gable. This door is the most distinctive feature of the building. It is constructed of vertical boards (probably originally beaded but now heavily weathered) on the exterior face secured to horizontal boards on the interior face with dozens of hand-wrought nails placed in a decorative pattern. The door is hung on hand-wrought strap hinges and is set in a beaded frame. Beaded corner boards and beaded and tapered rakeboards provide additional decorative elements to the building.

Frame meat house

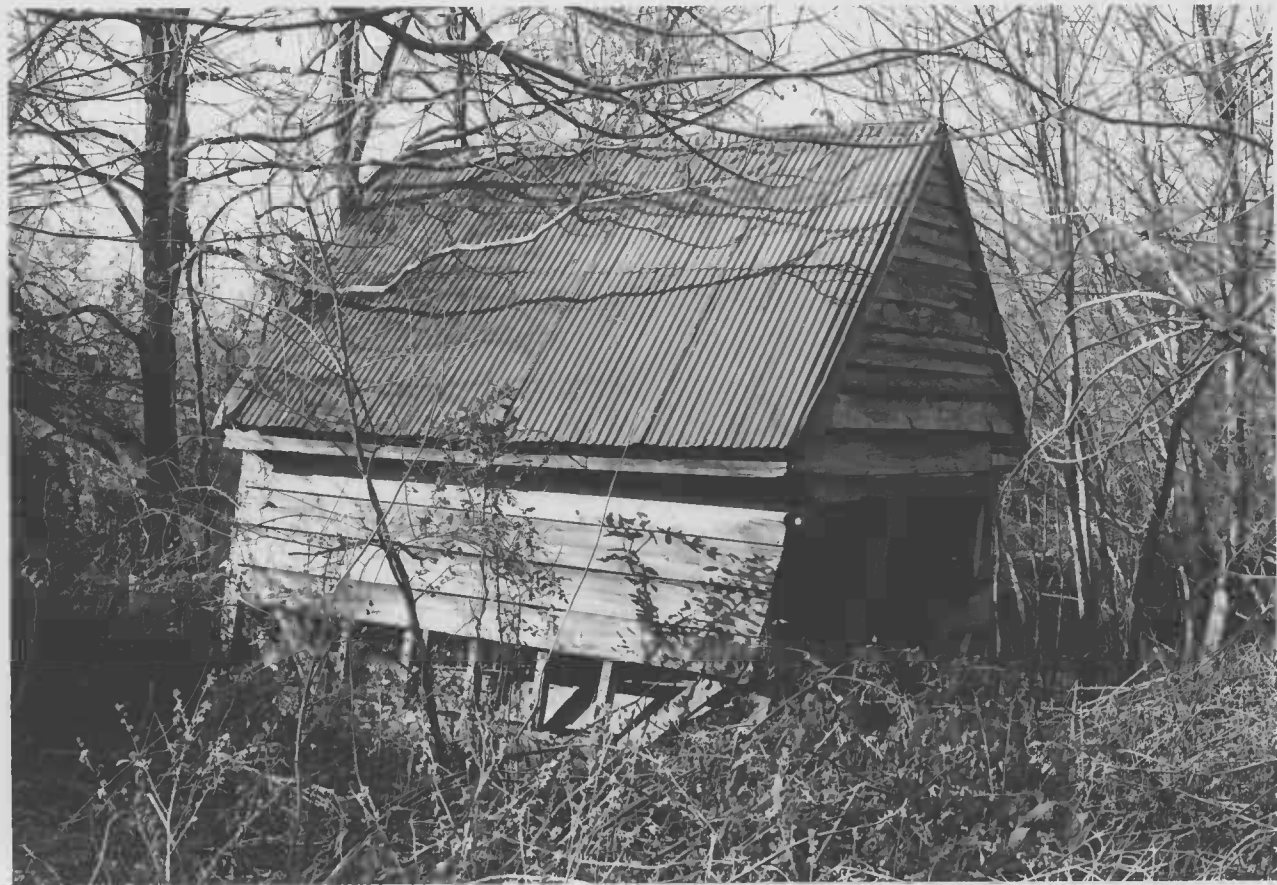
This early 19th century frame meat house was moved to this property at an unknown date earlier in the twentieth century. It is sited in line with an implement shed and a corn house along the west edge of the cultivated land to the southwest of the house.

Meat house to west of house
